# Condition Report on Plate Heat Exchanger in a Commercial Building in the Perth CBD

Eric Brogle

19 January 2021

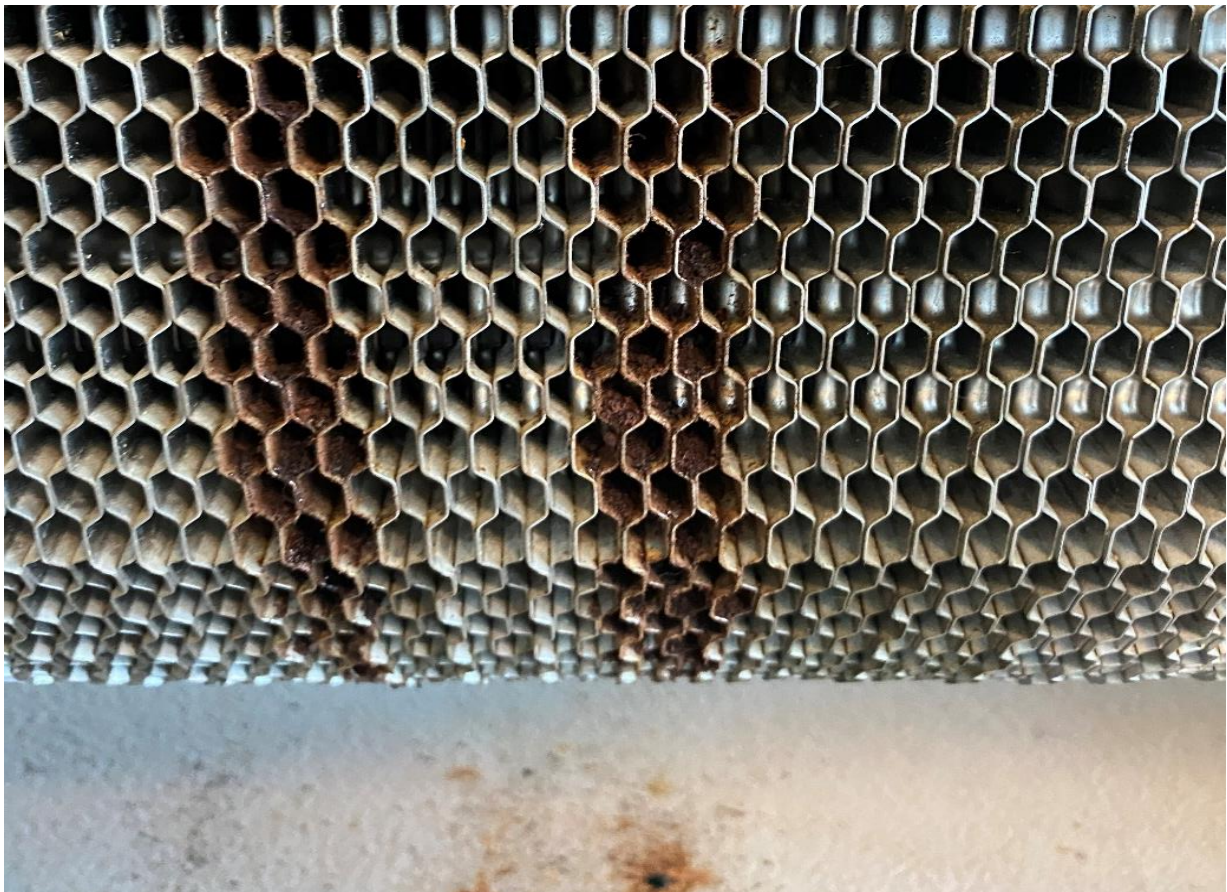
Photo 1 Shows signs of leakage from one of the heat exchangers.

**In this case the building manager is fortunate that they have a proactive mechanical contractor taking responsibility for the mechanical maintenance of the building. Whilst there has been some minor leakage from the heat exchanger as shown in Photo 1, it is clear from Photo 3 that it was only a matter of time before it turned into a catastrophic leak. In this case the cooling circuit removed heat from numerous data rooms, but the**

Both stainless-steel plate packs were replaced with genuine Sondex 0.6 mm titanium plates and NBR gaskets by Delta T Technologies (WA).

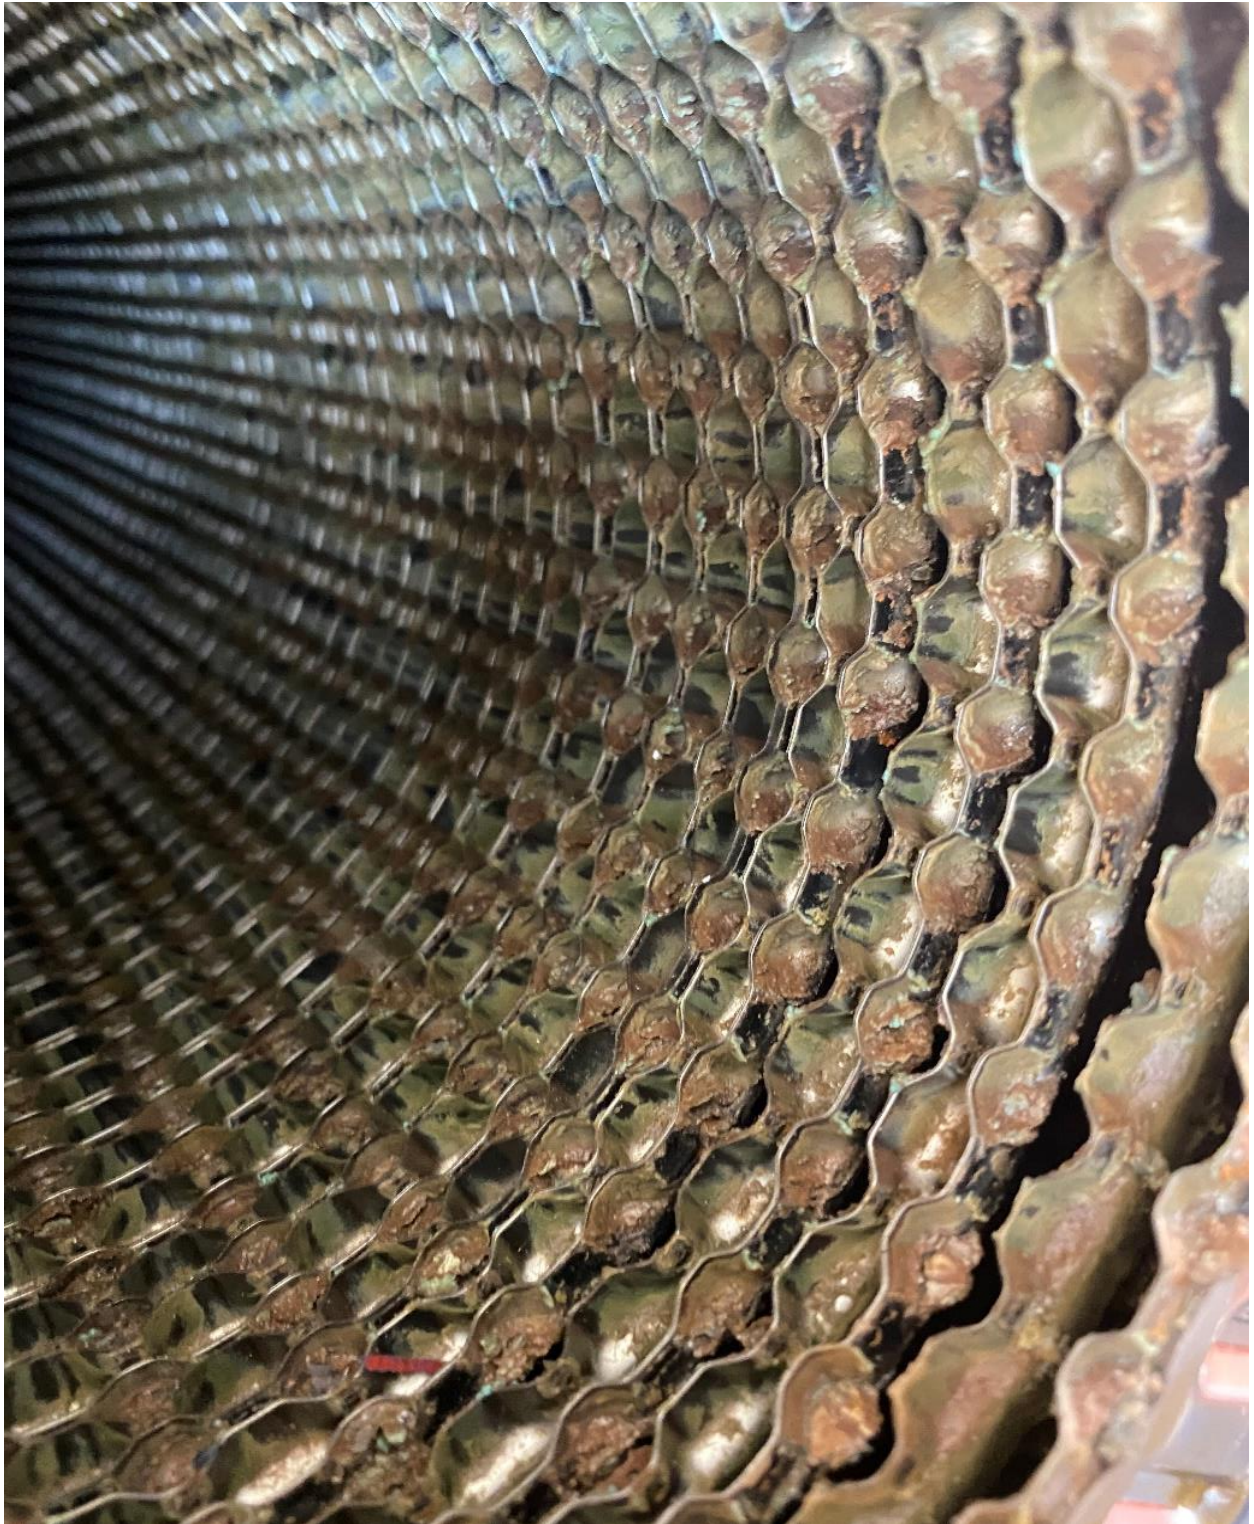
Photo 2 Showing scale and sludge deposits at plate entry.

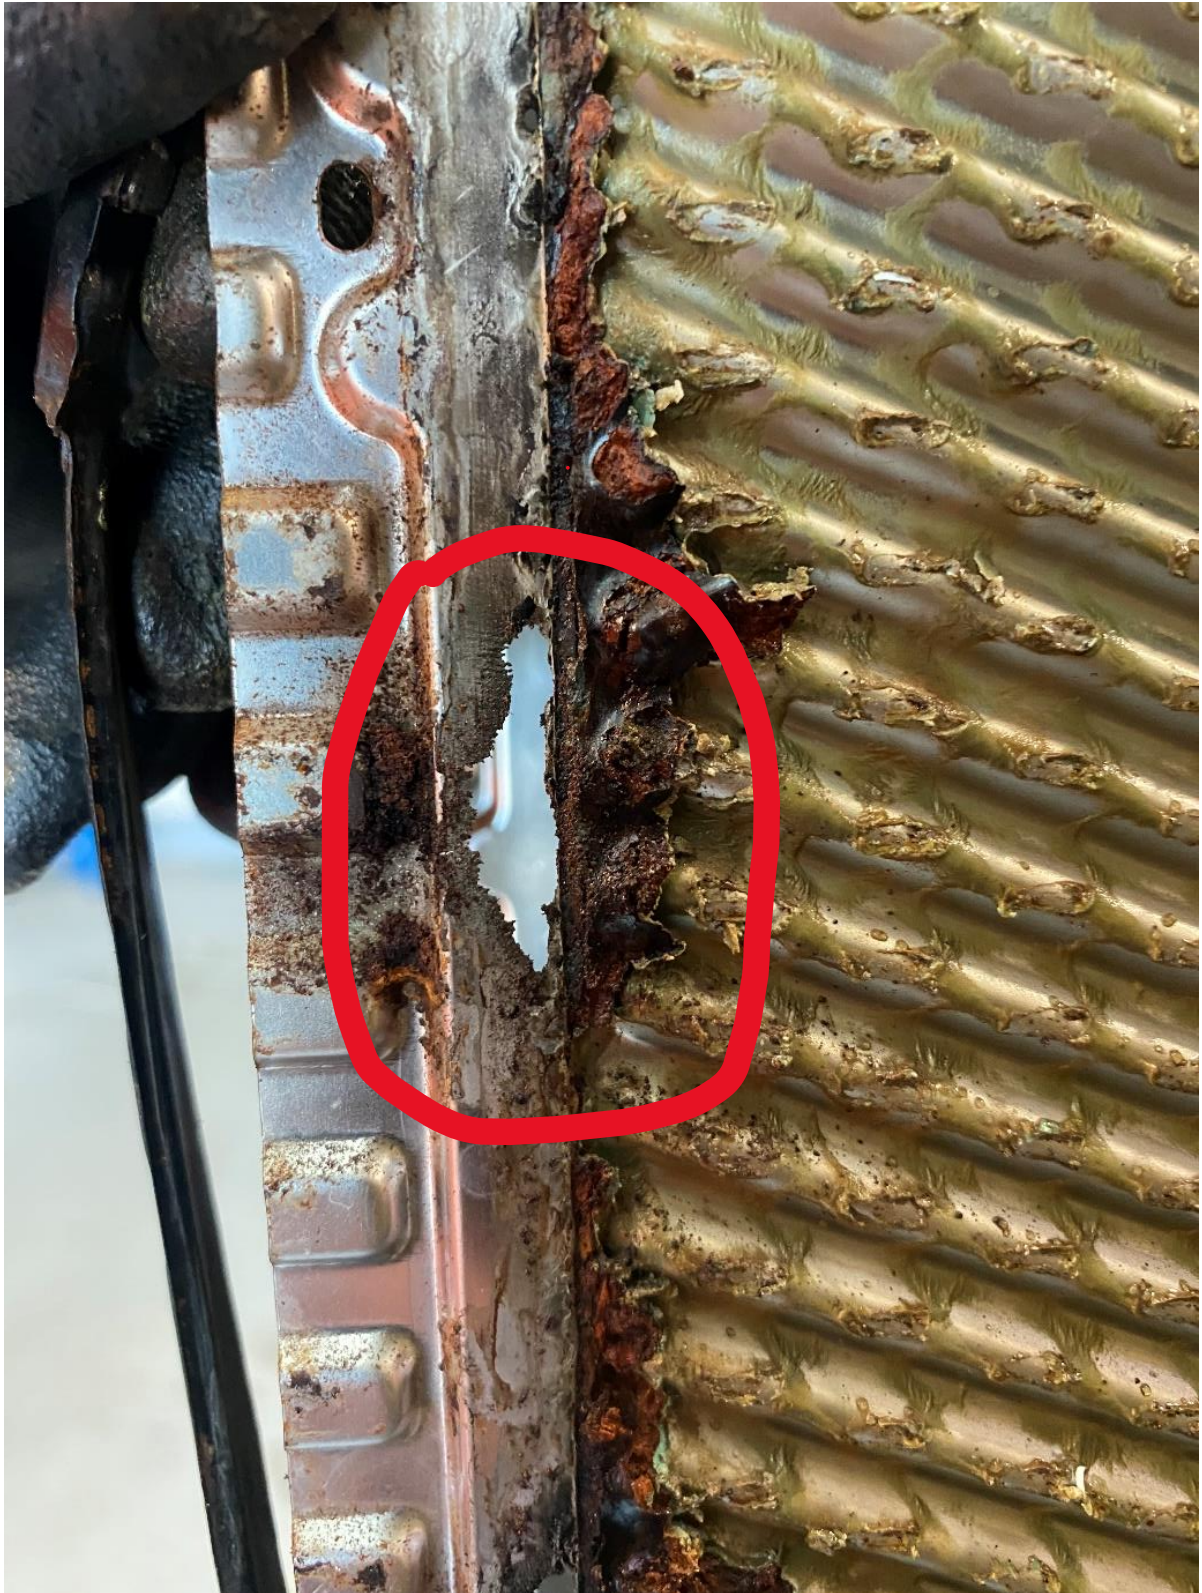
Photo 3 Showing corrosion hole under the gasket in the gasket groove on the long edge of the heat transfer plate.

The failure was clearly corrosion, there are numerous corrosion mechanisms but given the circumstances it is thought to be Crevice Corrosion.
