Brewery Plate Heat Exchanger Servicing

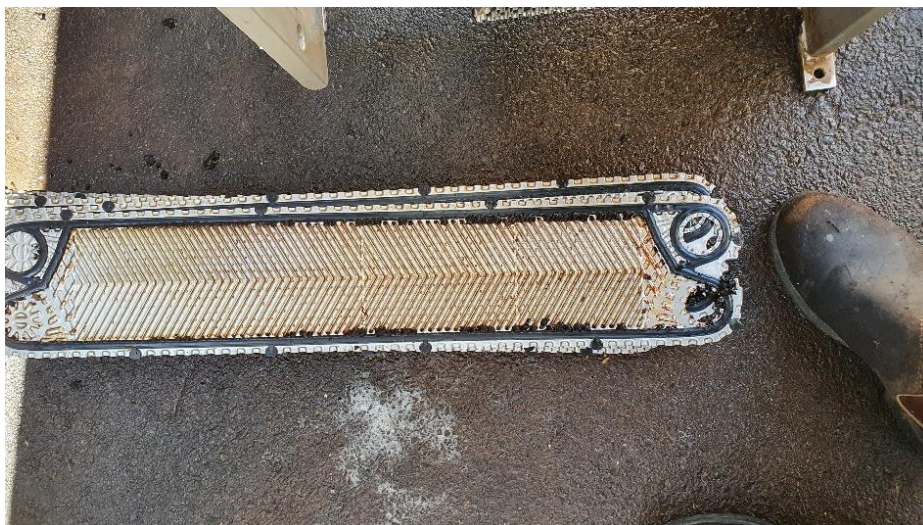
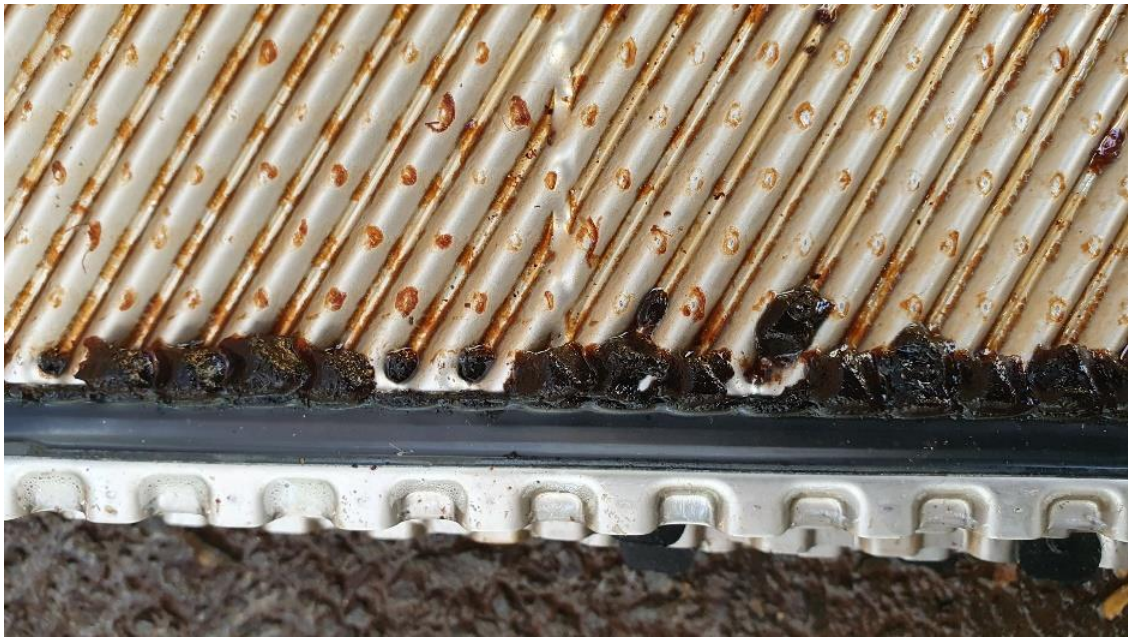
The heat exchanger was opened, and the gaskets were found to be compressed raising some concerns about sealing the heat exchanger on reassembly.

A substantial amount of organic material was found in the first pass which was not being removed by regular chemical cleaning.

The heat exchanger was being cleaned after every brew, but the velocity was not high enough to remove the material found.

Once cleaned the heat exchanger was reassembled and pressure tested with no leaks found.

Changes have been made to the chemical cleaning process and pipework has been modified resulting in an easier back flushing process.
